**Flood Control Project Maintenance
Levee Inspections**
LMA District Cover Sheet
Spring 2018 Levee Inspection Results

Reclamation District No. 0556 Upper Andrus

Spring 2018 Levee Inspection Results

Waterway			Bank	Unit Miles
Unit No. 01 Georgiana Slough			Right	5.48
	Spring (March - May)	Summer (June - August)	(September - November) Fall	Winter (December - February)
Unit Maintenance Rating (Fall Only)				
Date of Inspection	4/5/2018 - 4/5/2018			
DWR Inspector	Keith Millard			
Accompanied By	Alan Silva RD 556

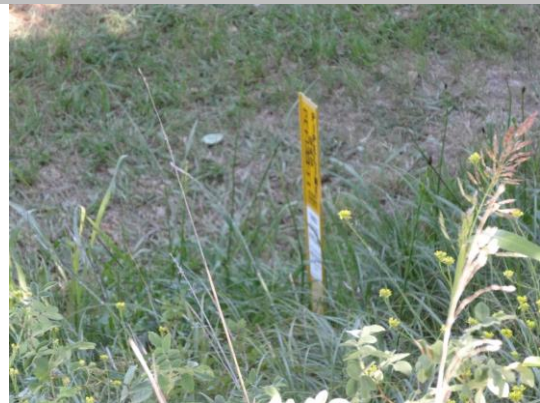
Photo 1 of 3 : UCIP_SP_2018_45564_74151.jpg

Comment Code					
Inspector Comment					
FS_ID:45564 DS_ID:20820 EP_NO: 3448 Repair Type: Non-Urgent Crossing Status: Indicator Found UCIP Comments: Dense vegetation inhibited visibility of gasline marker on WS. Need to contact owner to determine status of crossing. FIELD_STRUCT_DESC: 4.5-inch steel natural gas pipeline through the levee, 4 feet below the crown. Location marker on the waterside (WS) shoulder. Cut in pavement visible at the crossing. Gas line marker on the landside (LS) and on the opposite bank at Reclamation District No. 263 (RD0263). Pipe not located in February 1991. (Plans for construction of a 4.5-inch gas line across Georgiana Slough from Andrus Island to Tyler Island authorized under Permit No. 3448, 1960 - Pacific Gas and Electric Company [PG&E]). [Additional Reference(s): DWR Levee Log]. FS Date: 5/27/2015

Gasline marker present on LS.

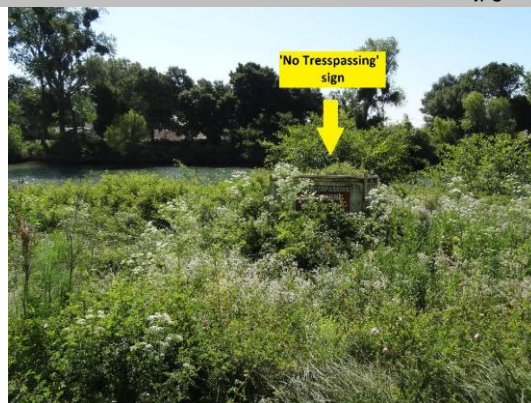
Photo 3 of 3 : UCIP_SP_2018_45564_74152.jpg

Comment Code						
Inspector Comment						
FS_ID:45564 DS_ID:20820 EP_NO: 3448 Repair Type: Non-Urgent Crossing Status: Indicator Found UCIP Comments: Dense vegetation inhibited visibility of gasline marker on WS. Need to contact owner to determine status of crossing. FIELD_STRUCT_DESC: 4.5-inch steel natural gas pipeline through the levee, 4 feet below the crown. Location marker on the waterside (WS) shoulder. Cut in pavement visible at the crossing. Gas line marker on the landside (LS) and on the opposite bank at Reclamation District No. 263 (RD0263). Pipe not located in February 1991. (Plans for construction of a 4.5-inch gas line across Georgiana Slough from Andrus Island to Tyler Island authorized under Permit No. 3448, 1960 - Pacific Gas and Electric Company [PG&E]). [Additional Reference(s): DWR Levee Log]. FS Date: 5/27/2015

View of WS. Dense vegetation limited visibility of 'No Trespassing' sign.

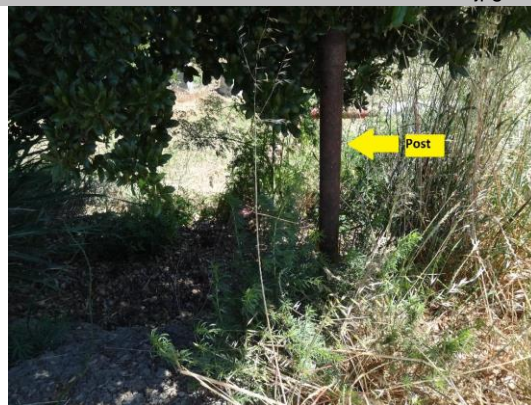
Photo 2 of 3 : UCIP_SP_2018_46799_74740.jpg

LM Start	1.17	Rating **	M	Issue No.	390
LM End	1.17	Issue Type +	En	Location *	
Category	Supplemental			GPS Latitude/Longitude	
				Start	End
Item	DWR UCIP Field Study			38.227534 °	38.227534 °
				-121.529396 °	-121.529396 °
DWR ID					
Comment Code					
Inspector Comment					
FS_ID:46799					
DS_ID:25106					
EP_NO: N/A					
Repair Type: Non-Urgent					
Crossing Status: Found					
UCIP Comments: Possible erosion above pipe on LS needs attention.					
FIELD_STRUCT_DESC: 8-inch steel irrigation pipe through the levee, at an unknown depth. Visible on the landside (LS), 6 feet away from the 10-inch pipe at HLM 1.17. Post likely for protection of vent located on the shoulder. Power pole next to pipe on the LS. This crossing was field discovered.					
FS Date: 5/27/2015

LS view: Post located above pipe on LS slope.

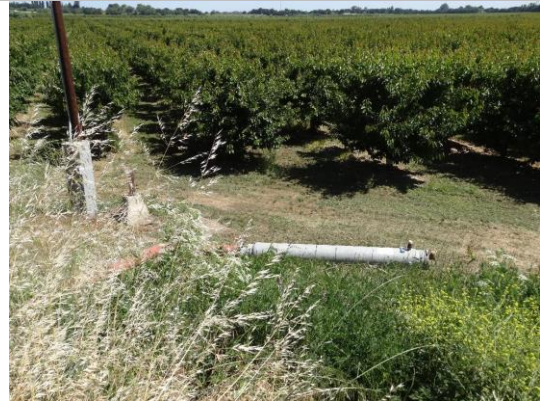
Photo 3 of 3 : UCIP_SP_2018_46799_74741.jpg

LM Start	1.17	Rating **	M	Issue No.	390 (cont)	
LM End	1.17	Issue Type +	En	Location *		
Category	Supplemental			GPS Latitude/Longitude		
				Start	End	
Item	DWR UCIP Field Study			38.227534 °	38.227534 °	
				-121.529396 °	-121.529396 °	
DWR ID						
Comment Code						
Inspector Comment						
FS_ID:46799						
DS_ID:25106						
EP_NO: N/A						
Repair Type: Non-Urgent						
Crossing Status: Found						
UCIP Comments: Possible erosion above pipe on LS needs attention.						
FIELD_STRUCT_DESC: 8-inch steel irrigation pipe through the levee,						
at an unknown depth. Visible on the landside (LS), 6 feet away from the						
10-inch pipe at HLM 1.17. Post likely for protection of vent located on						
the shoulder. Power pole next to pipe on the LS. This crossing was field						
discovered.						
FS Date: 5/27/2015

Electric pole next to pipe on LS.

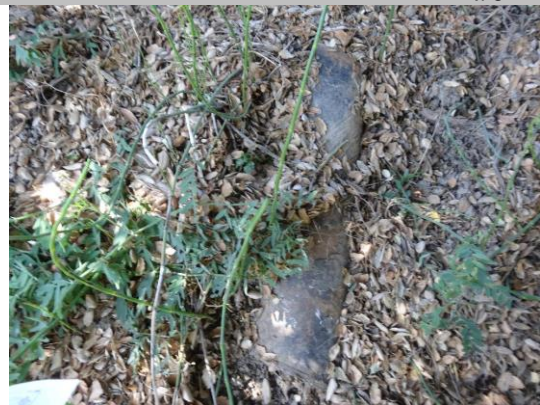
Photo 1 of 3 : UCIP_SP_2018_45683_74200.jpg

Comment Code						
Inspector Comment						
FS_ID:45683 DS_ID:20823 EP_NO: 11169 Repair Type: Non-Urgent Crossing Status: Found UCIP Comments: Appears abandoned in place and if so should be done so properly. Dense vegetation on WS limits visibility. FIELD_STRUCT_DESC: *ABANDONED* 10-inch steel irrigation discharge pipe through the levee, 3.8 feet below the crown. Located at the lower end of the rock revetment. (Plans to replace an existing 10-inch suction pipe with a 10-inch slant propeller pump on the levee authorized under Permit No. 4848, 1965 - Kay Dix Ranch Company. Retention of a 10-inch pipe through the levee, 3.8 feet below the crown, authorized under Automatic Board Order (ABO) issued as Permit No. 11169, 1975 - Darrell T. and B. M. Mealer). Abandoned in place. [Additional Reference(s): DWR Levee Log. USACE Sacramento O&M Manual 103, June 1954, (Station ""R"" 548+59.8), invert elevation 16.8 feet]. FS Date: 5/27/2015

LS view of pipe appearing abandoned in place.

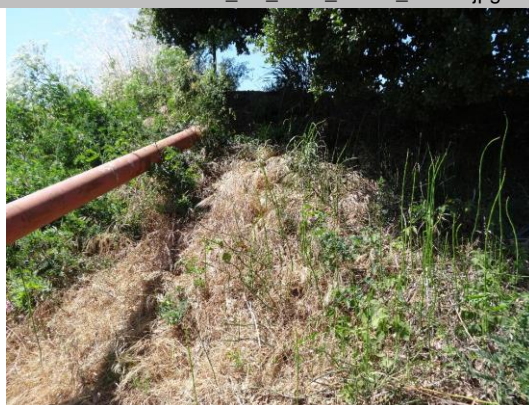
Photo 3 of 3 : UCIP_SP_2018_45683_74202.jpg

Comment Code						
Inspector Comment						
FS_ID:45683 DS_ID:20823 EP_NO: 11169 Repair Type: Non-Urgent Crossing Status: Found UCIP Comments: Appears abandoned in place and if so should be done so properly. Desnse vegetation on WS limits visibility. FIELD_STRUCT_DESC: *ABANDONED* 10-inch steel irrigation discharge pipe through the levee, 3.8 feet below the crown. Located at the lower end of the rock revetment. (Plans to replace an existing 10-inch suction pipe with a 10-inch slant propeller pump on the levee authorized under Permit No. 4848, 1965 - Kay Dix Ranch Company. Retention of a 10-inch pipe through the levee, 3.8 feet below the crown, authorized under Automatic Board Order (ABO) issued as Permit No. 11169, 1975 - Darrell T. and B. M. Mealer). Abandoned in place. [Additional Reference(s): DWR Levee Log. USACE Sacramento O&M Manual 103, June 1954, (Station ""R"" 548+59.8), invert elevation 16.8 feet]. FS Date: 5/27/2015

View up LS slope. 10" pipe (not visible) rests next to (visible) 8" pipe.

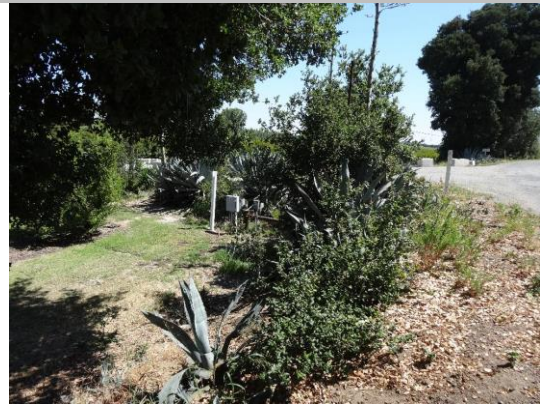
Photo 1 of 3 : UCIP_SP_2018_45692_74204.jpg

Comment Code						
Inspector Comment						
FS_ID:45692 DS_ID:20825 EP_NO: 13302 Repair Type: Non-Urgent Crossing Status: Found UCIP Comments: Seal beneath siphon breaker off LS toe leaking. Rodent activity near crown off LS shoulder. Need to contact owner about leaky seal. Dense vegetation prevented inspection of WS slope. FIELD_STRUCT_DESC: 6-inch steel irrigation discharge pipe and 2-inch galvanized iron electrical conduit through the levee, 2 feet below the crown. Siphon valve on the landside (LS) shoulder. Concrete stand and pump at the LS toe. Circuit box also at the LS toe. Cuts visible in pavement. 6-inch polyvinyl chloride (PVC) standpipe adjacent to the pipe off the LS toe. (Plans to install a 6-inch irrigation pipe and electrical conduit through the levee authorized under Permit No. 13302, 1981 - Kaydix Ranch). [Additional Reference(s): DWR Levee Log. USACE Sacramento O&M Manual 103, June 1954, (Station ""R"" 540+85), invert elevation 16.3 feet]. FS Date: 5/27/2015

Pipe, standpipe, electrical box at LS toe. Pumphouse in bush behind electrical box.

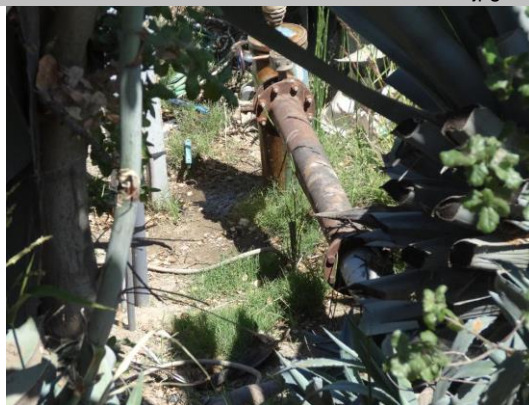
Photo 3 of 3 : UCIP_SP_2018_45692_74206.jpg

FS_ID:45692
DS_ID:20825
EP_NO: 13302
Repair Type: Non-Urgent
Crossing Status: Found
UCIP Comments: Seal beneath siphon breaker off LS toe leaking. Rodent activity near crown off LS shoulder. Need to contact owner about leaky seal. Dense vegetation prevented inspection of WS slope. FIELD_STRUCT_DESC: 6-inch steel irrigation discharge pipe and 2-inch galvanized iron electrical conduit through the levee, 2 feet below the crown. Siphon valve on the landside (LS) shoulder. Concrete stand and pump at the LS toe. Circuit box also at the LS toe. Cuts visible in pavement. 6-inch polyvinyl chloride (PVC) standpipe adjacent to the pipe off the LS toe. (Plans to install a 6-inch irrigation pipe and electrical conduit through the levee authorized under Permit No. 13302, 1981 - Kaydix Ranch). [Additional Reference(s): DWR Levee Log. USACE Sacramento O&M Manual 103, June 1954, (Station ""R"" 540+85), invert elevation 16.3 feet].

Closeup of pipe at LS toe. Seal beneath siphon breaker leaking.

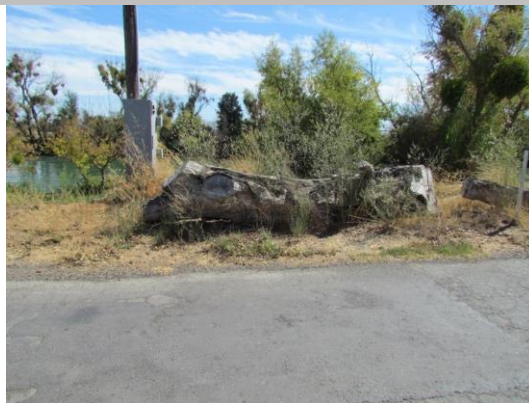
Photo 1 of 1 : SP_2018_RD0556_18_9_20180305_00002.jpg

Cut tree sections on the waterside levee shoulder remain to prevent parking.

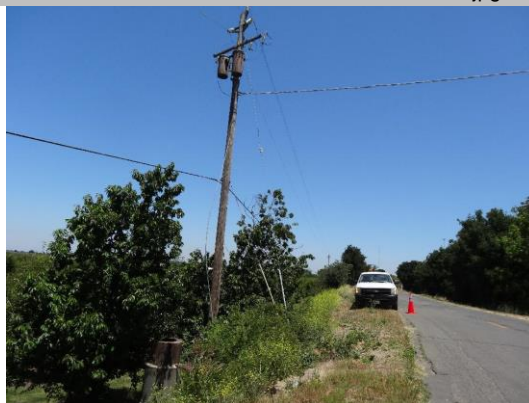
Photo 2 of 3 : UCIP_SP_2018_45743_74241.jpg

FS_ID:45743
DS_ID:20827
EP_NO: 11169
Repair Type: Non-Urgent
Crossing Status: Found
UCIP Comments: Dense vegetation on LS and WS limited accessibility.
FIELD_STRUCT_DESC: 8-inch steel irrigation discharge pipe through the levee, 3.5 feet below the crown. 1-inch air valve. Pump and gate valve on the waterside (WS) berm. 2-inch electrical conduit through the levee. 36-inch concrete standpipe and concrete block step on the landside (LS) slope. (Retention of a 10-inch pipe through the levee, 3.5 feet below the crown, and a pump and a gate valve on the WS berm authorized under Automatic Board Order (ABO) issued as Permit No. 11169, 1975 - Darrell T. and B. M. Mealer). [Additional Reference(s): DWR Levee Log, 10-inch pipe referenced. USACE Sacramento O&M Manual 103, June 1954, (Station ""R"" 528+02.1), 10-inch pipe referenced, invert elevation 16.6 feet].
FS Date: 5/27/2015

Service pole next to standpipe off LS toe.

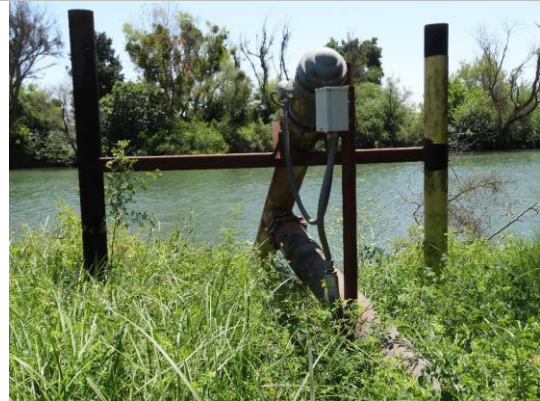
Photo 3 of 3 : UCIP_SP_2018_45743_74242.jpg

Comment Code					
Inspector Comment					
FS_ID:45743 DS_ID:20827 EP_NO: 11169 Repair Type: Non-Urgent Crossing Status: Found UCIP Comments: Dense vegetation on LS and WS limited accessibility. FIELD_STRUCT_DESC: 8-inch steel irrigation discharge pipe through the levee, 3.5 feet below the crown. 1-inch air valve. Pump and gate valve on the waterside (WS) berm. 2-inch electrical conduit through the levee. 36-inch concrete standpipe and concrete block step on the landside (LS) slope. (Retention of a 10-inch pipe through the levee, 3.5 feet below the crown, and a pump and a gate valve on the WS berm authorized under Automatic Board Order (ABO) issued as Permit No. 11169, 1975 - Darrell T. and B. M. Mealer). [Additional Reference(s): DWR Levee Log, 10-inch pipe referenced. USACE Sacramento O&M Manual 103, June 1954, (Station ""R"" 528+02.1), 10-inch pipe referenced, invert elevation 16.6 feet]. FS Date: 5/27/2015

Slant pump and pipe with 2" electrical conduit into WS slope.

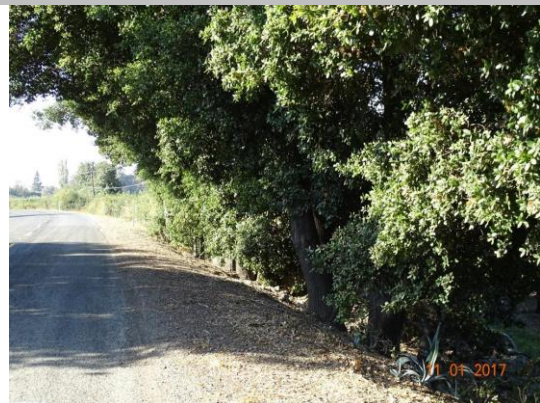
Photo 1 of 1 : SP_2018_RD0556_18_386_20180305_00032.jpg

LM Start	1.57	Rating **	M	Issue No.	386
LM End	1.65	Issue Type +	Ma	Location *	LS
Category	Earthen Levee			GPS Latitude/Longitude	
				Start	End
Item	Vegetation			38.224995 °	38.224623 °
				-121.535094 °	-121.536320 °
DWR ID	DWR_RD0556_01_f_2013_386				
Comment Code					
V2 : Remove the wild growth other than native grasses from the levee slopes.					
Inspector Comment

Remove the wild growth and trim trees from the landside levee slope.

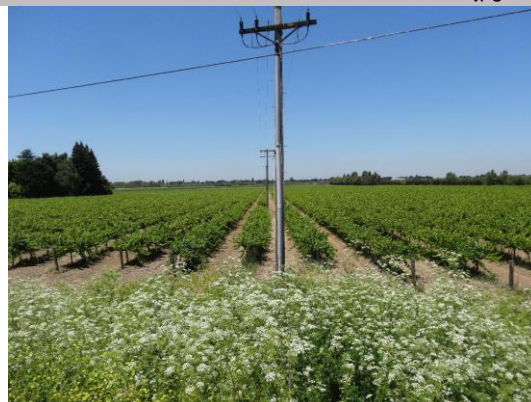
Photo 2 of 3 : UCIP_SP_2018_45746_74251.jpg

Comment Code					
Inspector Comment					
FS_ID:45746 DS_ID:20828 EP_NO: 3735 Repair Type: Non-Urgent Crossing Status: Indicator Found UCIP Comments: Dense vegetation on LS and WS limited accessibility. FIELD_STRUCT_DESC: 4-inch electrical conduit of an unknown material under Georgiana Slough and through its levees, 4 feet below the crown. Pump on the waterside (WS) berm. Power pole on the landside (LS) in alignment with the cuts in the pavement. (Plans for installation of a 12-kilovolt submarine cable under Georgiana Slough and through its levees authorized under Permit No. 3735, 1961 - Pacific Gas and Electric Company [PG&E]). [Additional Reference(s): DWR Levee Log]. FS Date: 5/27/2015

Cuts in pavement in alignment with electric pole off LS toe.

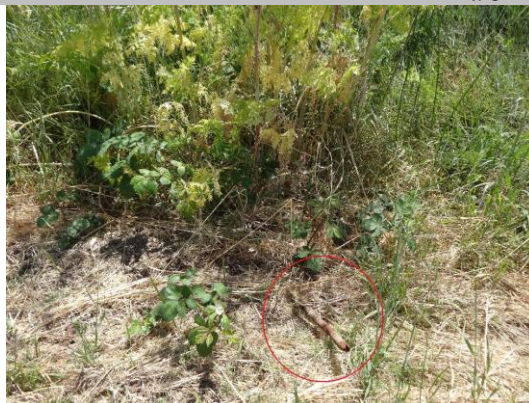
Photo 3 of 3 : UCIP_SP_2018_45746_74252.jpg

Comment Code						
Inspector Comment						
FS_ID:45746 DS_ID:20828 EP_NO: 3735 Repair Type: Non-Urgent Crossing Status: Indicator Found UCIP Comments: Dense vegetation on LS and WS limited accessibility. FIELD_STRUCT_DESC: 4-inch electrical conduit of an unknown material under Georgiana Slough and through its levees, 4 feet below the crown. Pump on the waterside (WS) berm. Power pole on the landside (LS) in alignment with the cuts in the pavement. (Plans for installation of a 12-kilovolt submarine cable under Georgiana Slough and through its levees authorized under Permit No. 3735, 1961 - Pacific Gas and Electric Company [PG&E]). [Additional Reference(s): DWR Levee Log]. FS Date: 5/27/2015

Pipe debris present at LS toe.

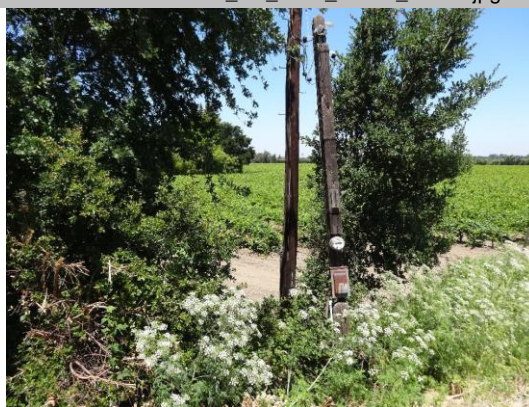
Photo 2 of 3 : UCIP_SP_2018_45764_74261.jpg

Comment Code						
Inspector Comment						
FS_ID:45764 DS_ID:20829 EP_NO: 11178 Repair Type: Non-Urgent Crossing Status: Found UCIP Comments: Dense vegetation on WS and LS. Some oil leakage inside pumphouse. FIELD_STRUCT_DESC: 8-inch steel irrigation discharge pipe through the levee, 3.7 feet below the crown. 2-inch electrical conduit through the levee, next to the 8-inch discharge pipe. 1-inch air valve and pump on the waterside (WS) berm. Service pole on the landside (LS) slope. Tin and wood pump house on the WS berm. 12-foot by 3-foot concrete standpipe on the LS. (Retention of an 8-inch pipe through the levee, 3.7 feet below the crown, a pump on the WS berm, and a service pole on the LS slope authorized under Automatic Board Order (ABO) issued as Permit No. 11178, 1975 - Allena D. Swett). [Additional Reference(s): DWR Levee Log. USACE Sacramento O&M Manual 103, June 1954, (Station ""R"" 511+00), invert elevation 16.4 feet]. FS Date: 5/27/2015

Pole on LS slope with electric box and 2-inch conduit.

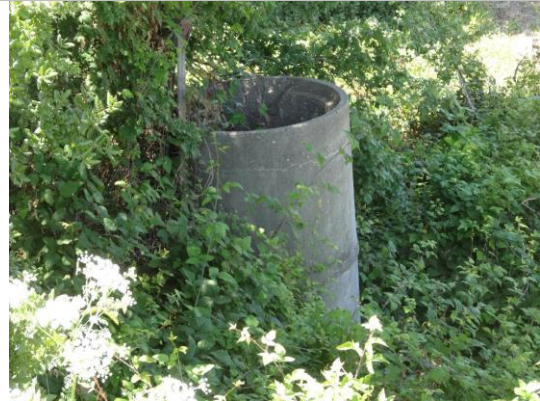
Photo 3 of 3 : UCIP_SP_2018_45764_74262.jpg

Comment Code					
Inspector Comment					
FS_ID:45764 DS_ID:20829 EP_NO: 11178 Repair Type: Non-Urgent Crossing Status: Found UCIP Comments: Dense vegetation on WS and LS. Some oil leakage inside pumphouse. FIELD_STRUCT_DESC: 8-inch steel irrigation discharge pipe through the levee, 3.7 feet below the crown. 2-inch electrical conduit through the levee, next to the 8-inch discharge pipe. 1-inch air valve and pump on the waterside (WS) berm. Service pole on the landside (LS) slope. Tin and wood pump house on the WS berm. 12-foot by 3-foot concrete standpipe on the LS. (Retention of an 8-inch pipe through the levee, 3.7 feet below the crown, a pump on the WS berm, and a service pole on the LS slope authorized under Automatic Board Order (ABO) issued as Permit No. 11178, 1975 - Allena D. Swett). [Additional Reference(s): DWR Levee Log. USACE Sacramento O&M Manual 103, June 1954, (Station ""R"" 511+00), invert elevation 16.4 feet]. FS Date: 5/27/2015

Standpipe on LS next to service pole.

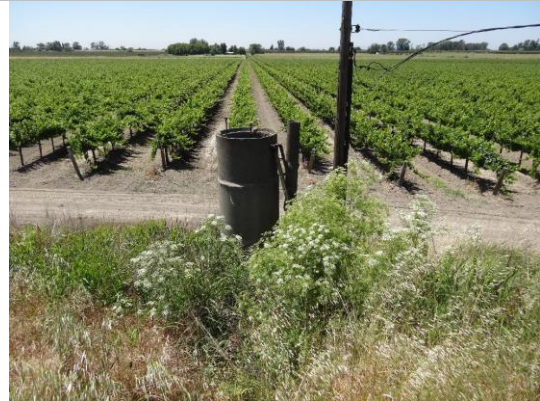
Photo 3 of 3 : UCIP_SP_2018_45786_74282.jpg

LS: 2 standpipes and service pole.

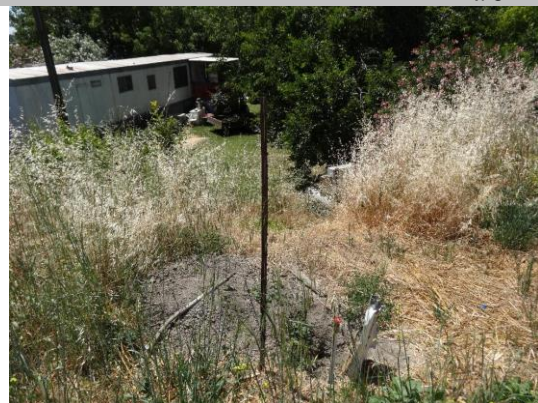
Photo 1 of 3 : UCIP_SP_2018_45803_74285.jpg

Pipe, pump @LS toe. 2'x2' hole off shoulder. Spigot in hole possibly for irrigation. House and service pole in background.

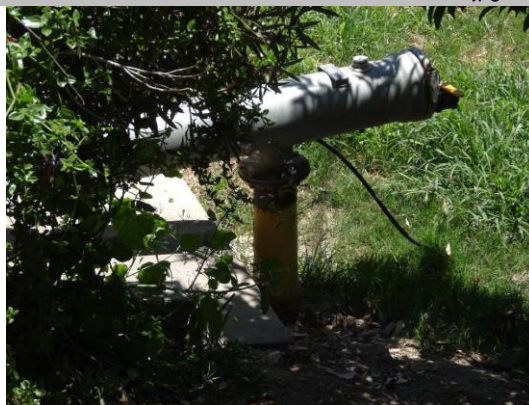
Photo 3 of 3 : UCIP_SP_2018_45803_74287.jpg

Closeup of 8-inch and 1.5-inch pipes and platform off LS toe.

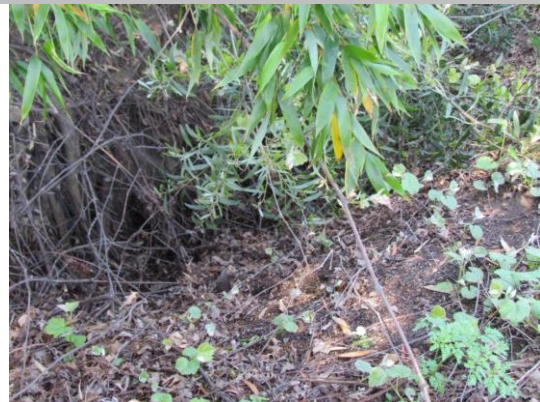
Photo 1 of 2 : SP_2018_RD0556_18_33_20180305_00018.jpg

RD 556 Unit 1 levee mile 2.72 fallen tree damage to shoulder and slope.

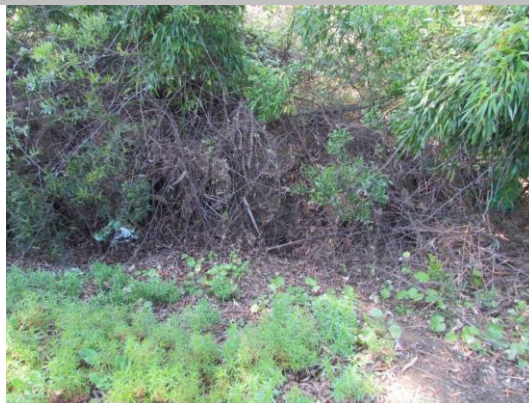
Photo 2 of 2 : SP_2018_RD0556_18_33_20180305_00019.jpg

RD 349 Unut 1 levee mile 2.72 the root ball of the fallen tree on slope landward.

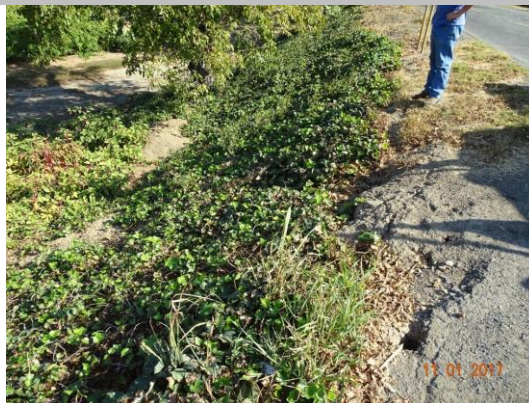
Photo 1 of 1 : SP_2018_RD0556_18_28_20180305_00013.jpg

Significant rodent activity in this area must be stopped. Holes should be backfilled.

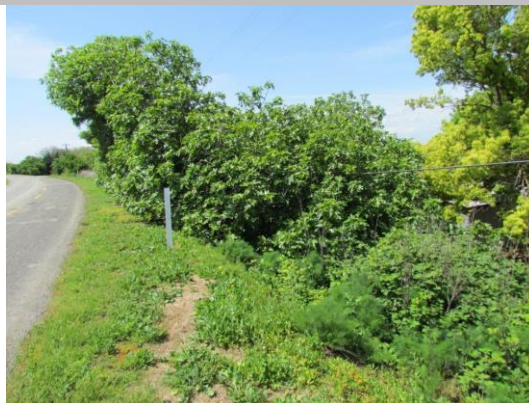
Photo 1 of 1 : SP_2018_RD0556_18_38_20180305_00025.jpg

556 Unit 1 levee mile 3.25-3.29 woody tree growth and vegetation blocking the view of the levee slope and toe.

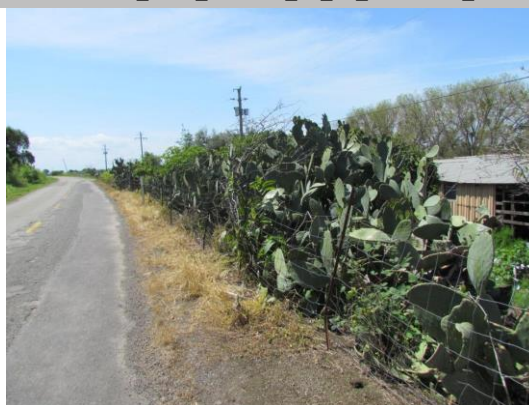
Photo 1 of 1 : SP_2018_RD0556_18_41_20180305_00027.jpg

556 Unit 1 levee mile 3.42-5.47 landside shoulder and slope.

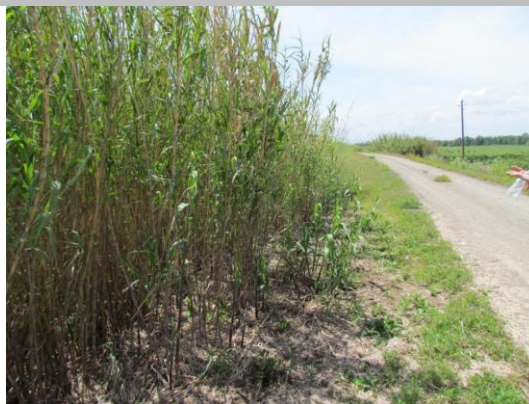
Photo 1 of 1 : SP_2018_RD0556_18_67_20180305_00030.jpg

Looking downstream on the waterside arundo completely blocking view of the slope and shoulder.

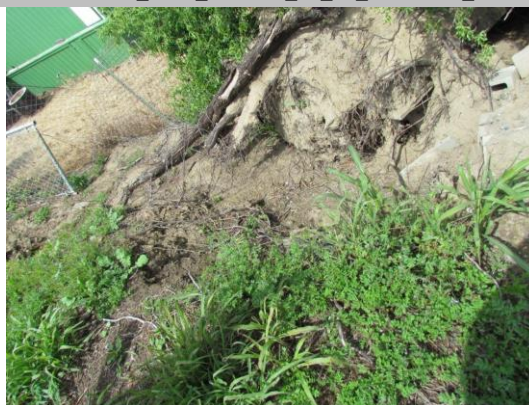
Photo 1 of 2 : SP_2018_RD0556_18_44_20180305_00028.jpg

RD 556 Unit 1 levee mile 5.46 fallen tree on landside slope and damage to the slope.

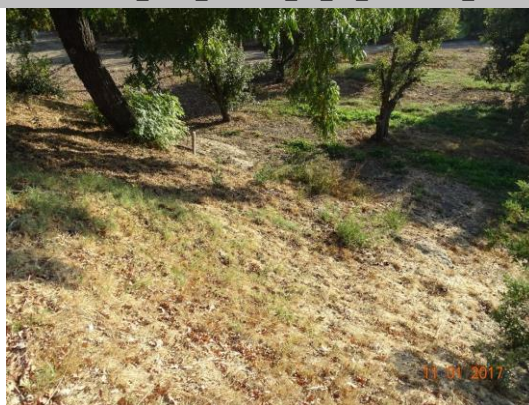
Photo 1 of 1 : SP_2018_RD0556_19_34_20180305_00019.jpg

Rodent burrows observed near the base of large nut tree on landside slope. Exterminate rodents and backfill burrows.

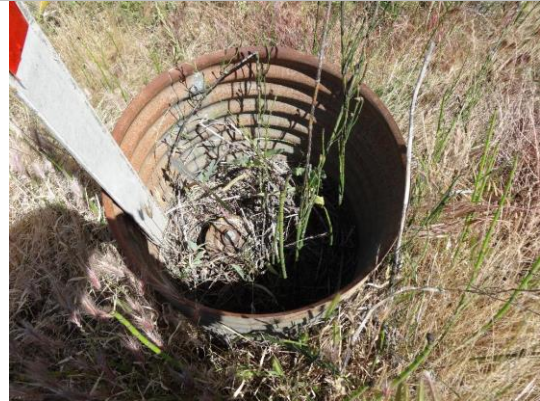
Photo 3 of 3 : UCIP_SP_2018_12543_20300.jpg

LS- siphon breaker in CMP riser. It needs cleaning.

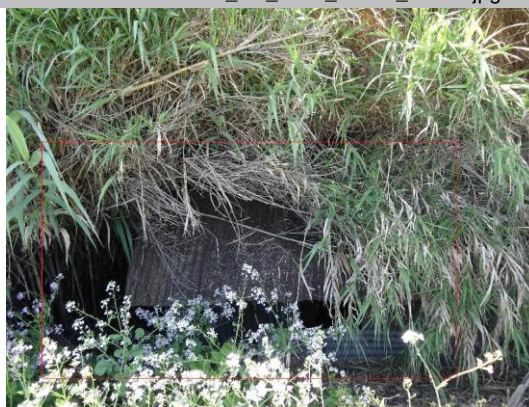
Photo 2 of 3 : UCIP_SP_2018_12545_20309.jpg

WS- pump house inside the dense vegetation.
